Manhole Inspection Summary

Manhole # S43KK_037MH

Insp Date: **8/13/08 10:38 AM**

Location Address: **Regester**

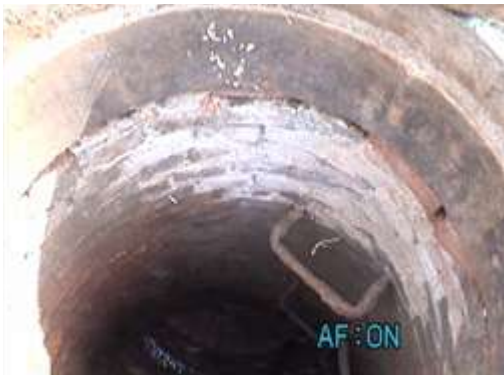
Defect 2

Condition: ☐ Sound ☐ Cracked ☐ Root Intrusion ☒ **Loose Brick** ☐ Deteriorated

Infiltration: ☐ None ☐ Joint ☐ Cracks ☒ **Mortar** ☐ Roots ☐ Wall

Loose bricks

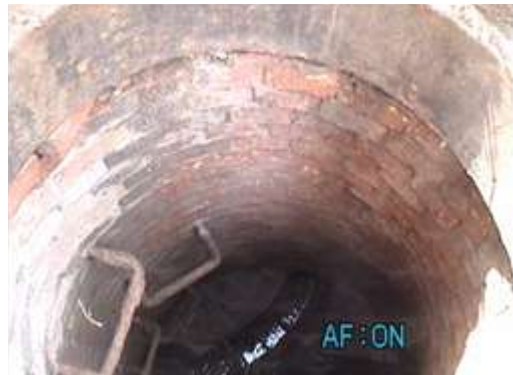
Defect 1

Infiltration: ☐ None ☐ Joint ☐ Cracks ☐ Mortar ☐ Roots ☒ **Wall**

Infiltration

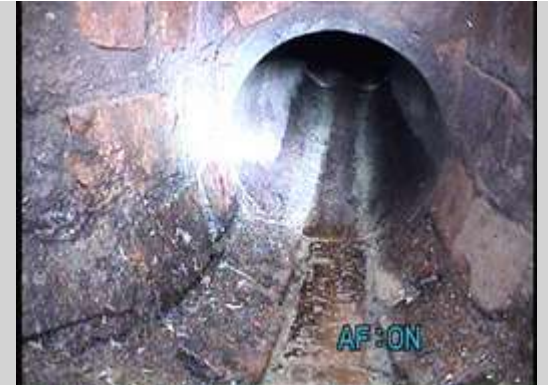
12 O'Clock Outflow

Pipe Height: **8.4** (in.) Rod and Bar (Angled)
Pipe Material: **Clay** ☐ Pipe Lined
Invert Depth: **9.55** (ft.) Flow Characteristics: **Fast**
Deposits: ☒ None ☐ Mud ☐ Sludge ☐ Debris ☐ Grease
Silt Depth: (in.) Deposits Extent:
Infiltration: **None** Pipe Seal Cond: **Sound**

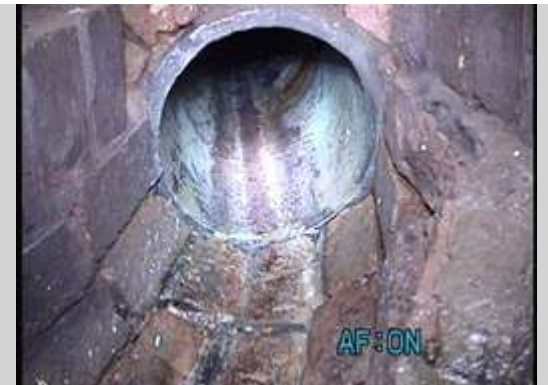
3 O'Clock Inflow

Pipe Height: **8.4** (in.) Rod and Bar (Angled)
Pipe Material: **Clay** ☐ Pipe Lined
Invert Depth: **9.20** (ft.) Flow Characteristics: **Fast**
Deposits: ☒ None ☐ Mud ☐ Sludge ☐ Debris ☐ Grease
Silt Depth: (in.) Deposits Extent:
Infiltration: **None** Pipe Seal Cond: **Sound**

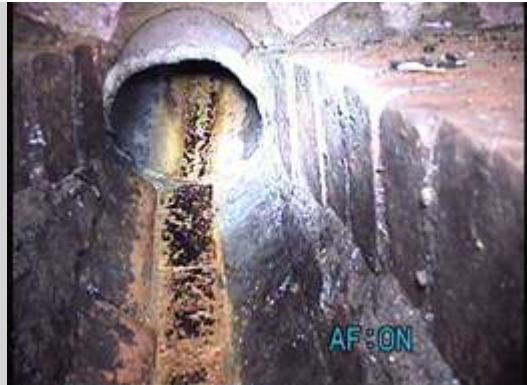
5 O'Clock Inflow

Invert Depth: **8.45** (ft.) Flow Characteristics: **Slow**

Infiltration: **None**

Pipe Seal Cond: **Sound**

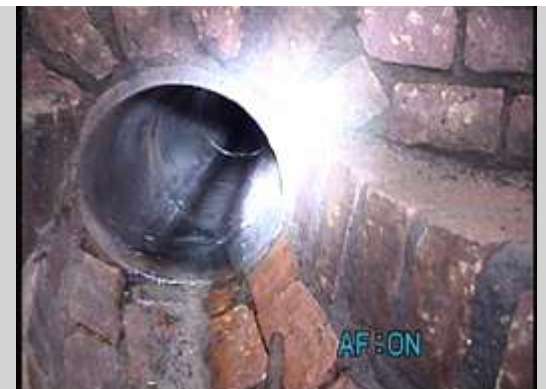
9 O'Clock Inflow

Invert Depth: **8.80** (ft.) Flow Characteristics: **Fast**

Infiltration: **None**

Pipe Seal Cond: **Sound**
